Operating Experience Weekly Summary 97-19

May 2 through May 8, 1997

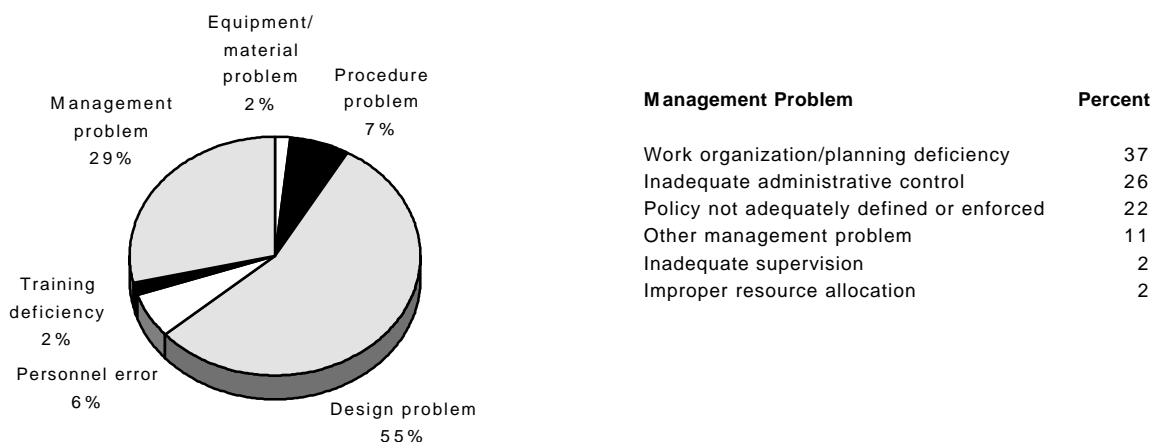
Figure 2-1. Distribution of Root Causes for Error in Equipment or Material Selection¹

Operating Experience Analysis and Feedback (OEAF) engineers reviewed the Occurrence Reporting and Processing System (ORPS) database for reports with a direct cause of design problem, error in equipment or material selection, and found 189 occurrences. Of these reports six involved pressurized drums. Four reports cited drums that did not have venting capability; another identified an incompatibility between the drum and its contents where acids corroded the iron present in the metal drum and produced hydrogen gas. The last report involved the overpressurization of a 55-gallon drum used as a pesticide sprayer. Figure 2-1 shows the distribution of root causes reported by facility managers for these 189 events. Design problem represented 55 percent of the root causes and management problems, 29 percent. Work organization/planning deficiency accounted for 37 percent of the management problems.

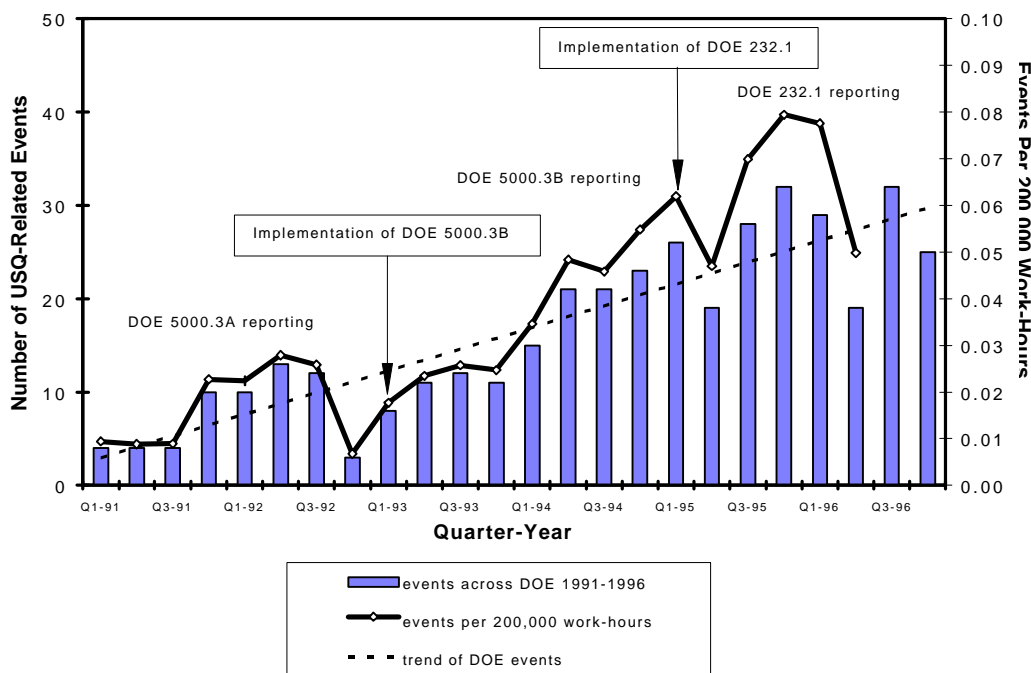
Figure 1-1. Reprint of Graph Showing Trend of USQ-Related Events Across DOE 1991-1996¹

In Weekly Summary 97-12, Operating Experience and Feedback (OEAF) engineers published a graph showing the trend of Unreviewed Safety Questions (USQ) across the DOE complex since 1991. We also asked six questions related to the state of safety at DOE. The following is a reprint of the graph, the six questions, and the responses we received for each question.

¹OEAF Engineers screened the ORPS database for the narrative "Unreviewed Safety Question" and the years 1991 to 1996 and found 400 reports describing 403 occurrences. Based on a random sample of 30 reports, OEAF engineers determined that each column is accurate within ± 3.9 percent.
